# Loss of an F35 fighter jet – The case for Human Factors Integration

Kevin Hayes<sup>1</sup> & Daniel Boardman<sup>2</sup>

<sup>1</sup>Defence Accident Investigation Branch, UK <sup>2</sup>Defence Accident Investigation Branch, UK

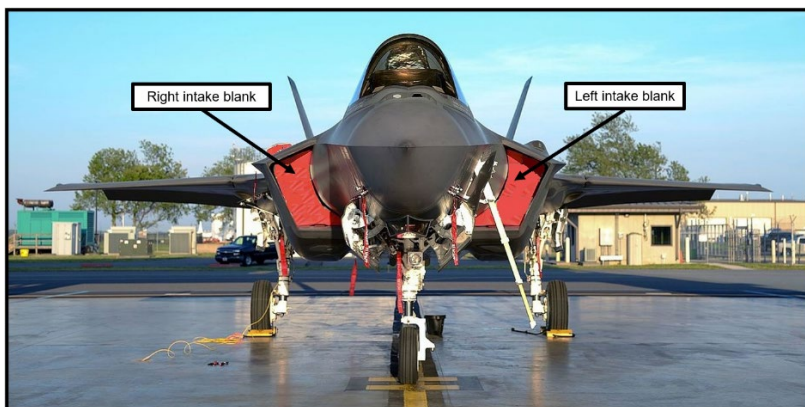
To conduct the engine inspection, Eng 1 removed the right intake blank (Figure 1) and climbed down the intake to gain access to the front face of the engine. On completion of this task, they took the right intake blank down to the hangar for storage. When Eng 2 came up on deck to conduct their element of the servicing, they found the exhaust blank on the deck a couple of metres behind the aircraft. Eng 2 safely stowed this blank and upon completing their servicing took it to the hangar for stowage. The exhaust blank was the only blank Eng 2 observed in or around BK18 that night. Their part of the servicing required climbing into the cockpit which involved considerable activity immediately adjacent to the left intake. Neither engineer reported interacting with the left intake blank during their elements of the servicing.

Figure 1: Representative image of an F35 with intake blanks fitted.

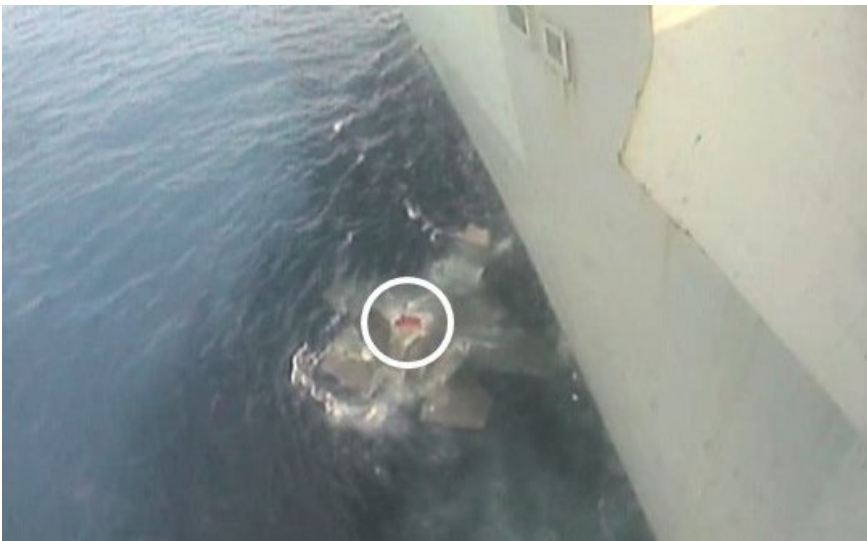
to the runway and converted the aircraft to short take-off mode. At the direction of the Captain of the Flight Deck the pilot conducted engine run up checks, confirmed all engine indications were normal, selected take-off power, 97% Engine Thrust Request (ETR), and released the brakes (DSA, 2022). The pilot reported that the initial acceleration felt normal, but then decreased. On checking the engine displays they discovered that the power was low, at 74% ETR. The pilot then selected maximum power (100% ETR), but the engine continued to deliver lower than expected acceleration. Due to the resulting low speed of BK-18, the pilot attempted to abort the take-off but was unable to stop the aircraft before the end of the flight deck and ejected (DSA, 2022). The ejection was successful, the parachute deployed, and the pilot landed on the flight deck suffering only minor injuries. The aircraft impacted the sea and was seen to be afloat passing down the port side of the ship. The left intake blank was seen to float out of the Auxiliary Inlet of BK18 before it sank (Figure 2). The blank was subsequently recovered by a sea boat dispatched to recover all flotsam (Figure 3).

Figure 2: Left Intake blank floating out of the BK18's Auxiliary Inlet.

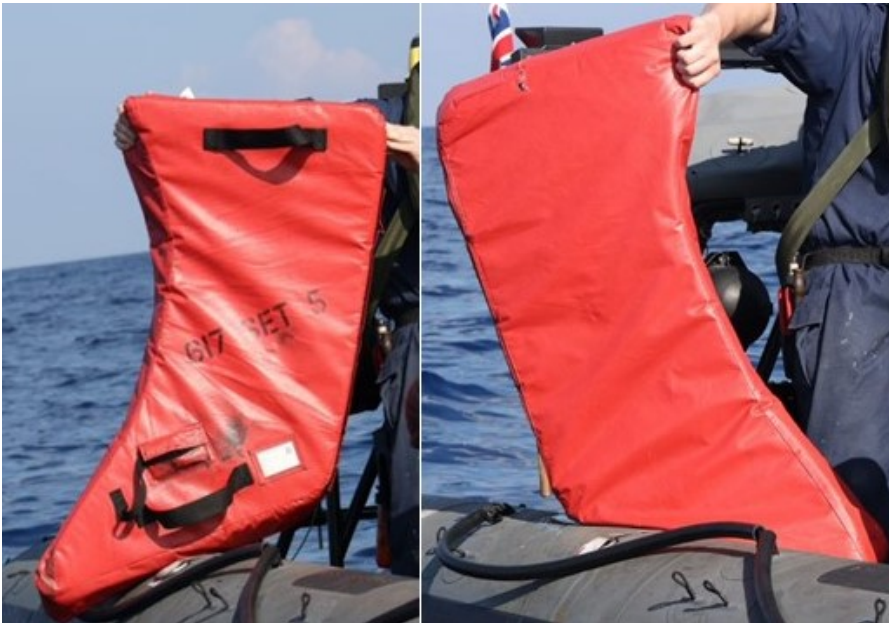
Figure 3: Left intake blank recovered from the sea.

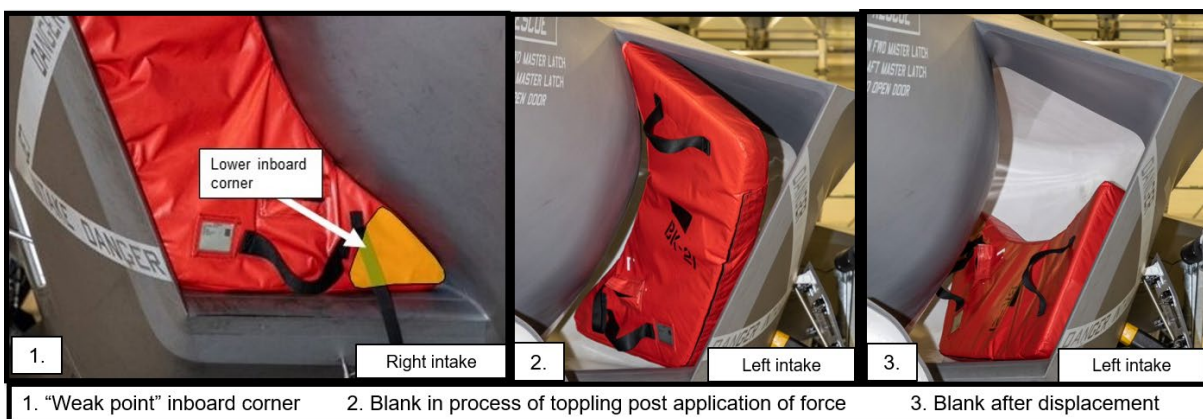
As part of the safety investigation a convenience sample of six engineers was taken as a preliminary test of the possible variance in successfully fitting the left and right intake blanks into an aircraft. Nine other aircraft with pre-fitted blanks were also sampled to account for any changes in the behaviour of the participants as a consequence of being observed (McCambridge et al, 2013). The installation of the blanks was found to vary considerably, with some installations having minimal contact with the aircraft intake's inner surface. The complex geometry of the intake often resulted in the inboard lower corner sitting proud of the airframe. Further engineering investigation determined that this inboard lower corner was a weak point that could cause the blank to rotate and topple (Figure 4) when a force equivalent to a strong breeze was applied (Barua, 2019). Once toppled, the blank was susceptible to further migration down the intake, beyond view, with the equivalent strong breeze force.

Figure 4: Images from trial demonstrating blank weak point.

- Ensuring Red Gear is managed in line with extant tool control and aircraft maintenance documentation processes so that its installation on aircraft can be accounted for at all times.
- Ensuring that the blank fitment procedure is clarified and standardised across the F35 force.
- That an assessment be made on the performance of blanks whilst being used in both the land environment and during embarked operations in order to ensure they are fit for purpose.
- That safety reporting from all global users of the F35 is shared between nations.
- To develop a warning to the pilot of a mismatch between commanded and delivered thrust prior to commencing a take-off.
- Ensuring that fatigue management plans are in place for future F35 deployments and that the staffing levels are realistically assessed against the required task output.
