Component Size Mismatch in Total Hip Arthroplasty: Identifying Risk Factors associated with this Surgical Never Event

Abstract. This paper presents an evaluation into the causes of the surgical Never Event ‘*Component Size Mismatch*’ in total hip arthroplasty. A single-centre prospective service evaluation was conducted at specialist orthopaedic hospital in the UK. Hierarchical Task Analysis and Healthcare Failure Modes and Effects Analysis were used to analyse perioperative procedures and identify potential causes and interventions. Key vulnerabilities in the system included, but were not limited to, poor implant labelling, distractions, communication error, and a difficult working environment. Interventions to reduce this Never Event are proposed and could be tested in simulation environments.

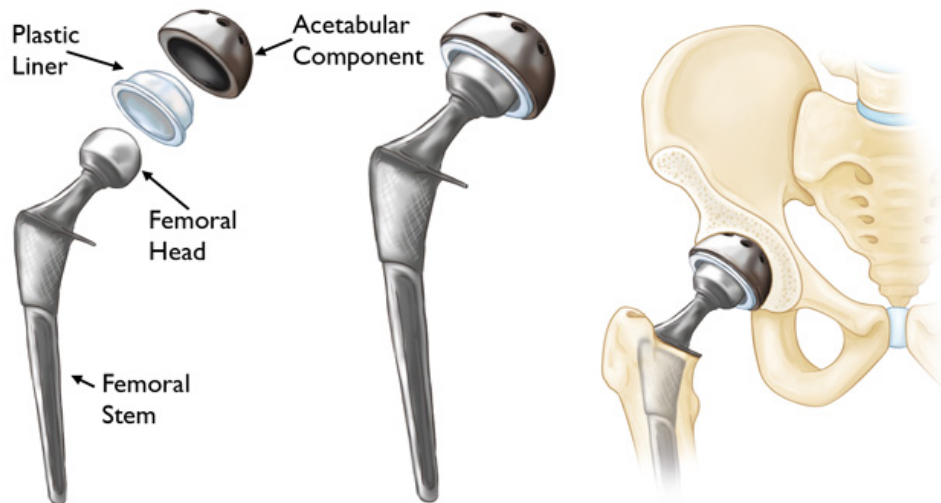
Total hip arthroplasty is a surgical procedure which involves the replacement of the hip joint with a prosthesis consisting of four main components (Figure 1). The acetabular cup, liner, and femoral head must all be matched for size to achieve faultless functioning of the prosthesis. If incorrectly matched the hip replacement can cause the patient unnecessary pain, poor function, additional operations, and increased risk of mortality (revision hip and knee surgery has a mortality rate of up to 2.5%) (NJR, 2012).

Figure 1. Total hip replacement (AAOS, 2015)

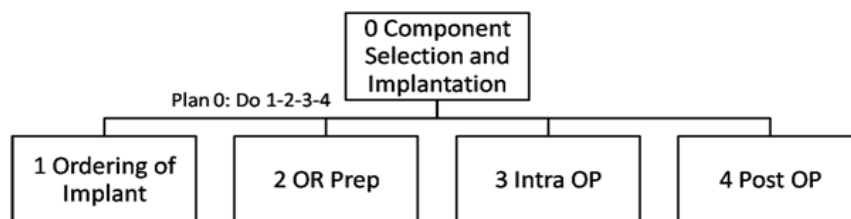
The HTA (Figures 2 and 4) presents the key goals and tasks involved in component selection during the pre and intra-operative stages of total hip arthroplasty, and the recording and documentation of component sizes during the post-operative stage. The overall goal (0) was *Component Selection and Implantation*, with 4 sub-goals/stages: 1: *Ordering of implant*, 2: *OR prep*, 3: *Intra OP*, and 4: *Post OP*. Of these 4 sub goals/stages, the HFMEA discussions identified that whilst stages 1, 2, and 4 all had tasks which could lead to errors, the errors were not relevant to CSM, or were too undetectable or infrequent to warrant further HFMEA analysis. Only stage 3(during the Intra OP tasks) included errors specific to CSM.

Figure 2.Highest level of HTA, showing four main stages of process.

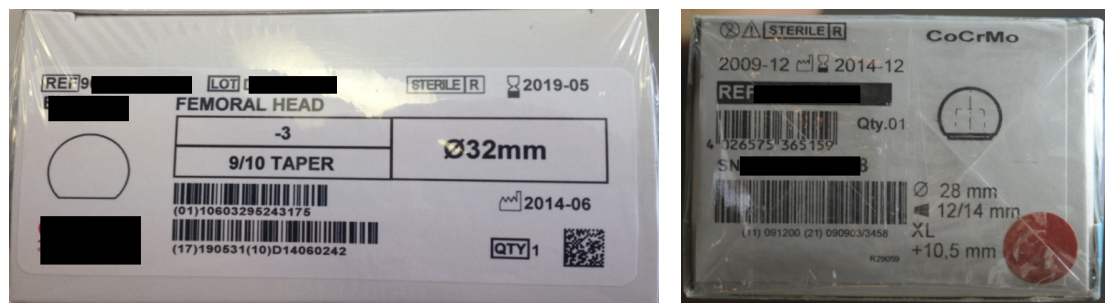
Figure 4. Stage 3 of the HTA - Trialling acetabulum size, femoral stem head size, and Definitive implant selection.

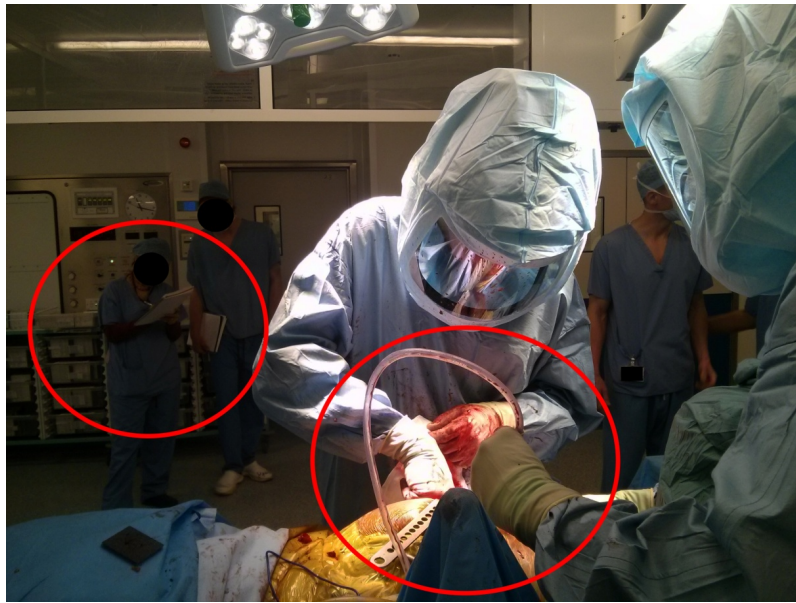
The luminance under the lighting of the laminar flow canopy (used to filter air) appeared to be higher than the rest of the OR, resulting in a high contrast between areas (Figure 5). As the visual check of the implant size by the surgeon must be conducted outside of the laminar flow canopy in order to reduce infections, this difference in contrast has the potential to significantly reduce visual acuity (Foxwell and Stevens, 1955). The size of the sterile surgical flow canopy may require the surgeon to read text on the packaging from a distance of approximately 1.75m, and the HFMEA output raised reading labels from a distance as a potential cause to CSM, with label text size being too small to cater to this.

Figure 5. Example of luminance contrast within the OR.
